Case report**Retrieval of a Separated Instrument from the Root Canal using Ultrasonics -A Case Report**

Nidhi B Hathila¹, Chintan Joshi¹, Uma Gohil¹, Vishal Changlani¹, Digisha K Damor²

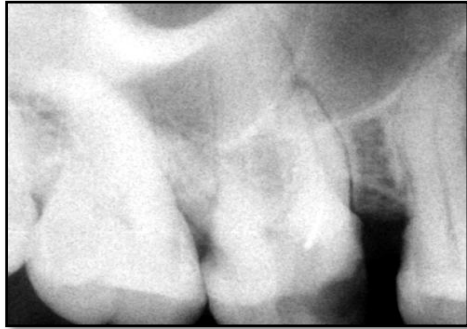
Figure 1: IOPA of tooth #26 shows fractured instrument in mesiobuccal canal

Access cavity preparation was done under local anesthesia in tooth #26. Root canal orifices were located with the help of DG 16 explorer and widened using Gates Glidden drills (Dentsply International) (GG) and the patient was recalled for further treatment. During the next visit, the tooth was again isolated and opened, then working length was measured using electronic apex locator and then confirmed using IOPA and biomechanical preparation was carried out. During the course of biomechanical preparation, a S1 Hand Protaper Nickel- Titanium (NiTi) file got separated at the coronal region of the mesiobuccal root canal. On radiographic examination, as shown in **figure 1**, the separated instrument was visible in coronal region of mesiobuccal canal orifice. The patient was informed about the instrument inside the canal and ill-effects of keeping it untouched.

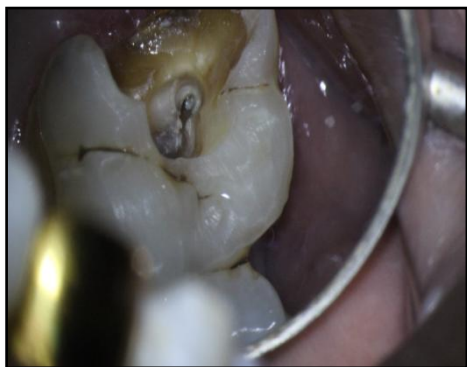
Figure 2: Fractured Instrument visible in coronal third of mesiobuccal canal under dental operating microscope

Exact location of separated instrument within the canal was confirmed under the dental operating microscope (PRISMA DNT, labomed) which is seen in **figure 2**. The separated instrument was located in the centre of mesiobuccal canal. Mesiobuccal canal orifice was enlarged using Gates Glidden drills up to #3. Modified Gates-Glidden drills (Dentsply International) were used to create circumferential staging platform to expose 2-3 mm of the coronal most part of the broken instrument. After this ProultraUltrasonic tip no. 7 in satelec ultrasonic handpiece at a power setting of 3 was placed into the mesiobuccal canal between the exposed end of the file and the prepared staging platform and activated to loosen the fractured instrument and continuous irrigation was done. Following the ultrasonic activation, the instrument fragment floated out from the canal. Fractured instrument was found to be approximately 5mm in length. **Figure 3** shows radiograph after removal of fractured instrument. The patency of the mesiobuccal canal was confirmed under the dental operating microscope and an IOPA was taken to confirm the same. **Figure 4** shows confirmed working length radiograph.

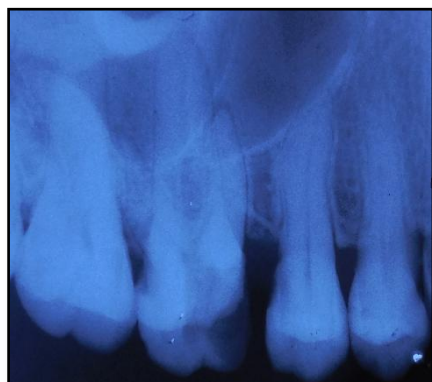
Figure 3: Radiograph shows retrieved instrument from mesiobuccal canal

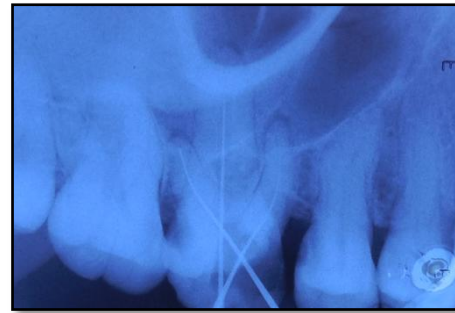
Figure 4: working length determination

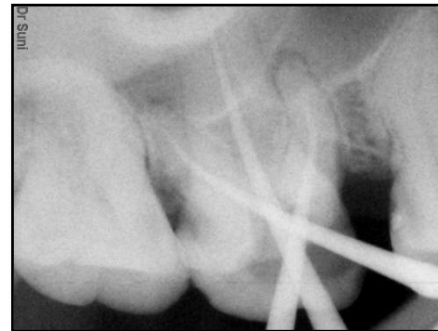
Figure 5: Mastercone Radiograph

Interappointment dressings of calcium hydroxide were given and the patient was recalled for obturation. Master cone was selected and checked radiographically as seen in **figure 5**. The root canals were obturated by single cone technique using guttapercha and AH Plus root canal sealer. Coronal restoration was done with silver amalgam. **Figure 6** shows completed obturation and post endodontic coronal restoration on radiograph.

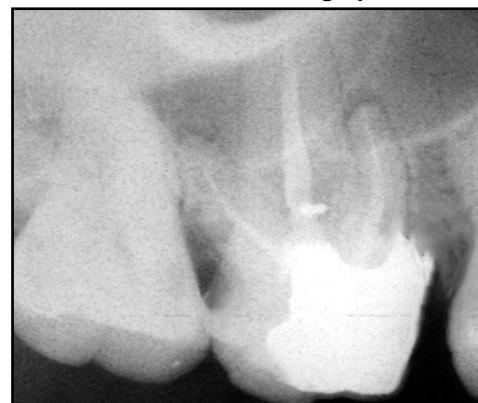
Figure 6: Obturation and Coronal Restoration Radiograph
