REPLACEMENT OF MISSING HALLUX WITH GLOVE TYPE SILICONE PROSTHESIS- A CASE REPORT

ABSTRACT

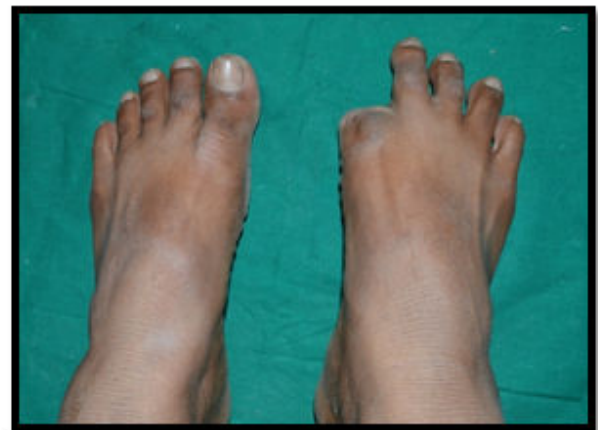
A male patient, aged 38 years, reported to the department, with a history of loss of right hallux (greater toe), about 3 years back, due to occupation-related trauma. Clinical examination of the affected foot revealed amputated hallux from metatarsal phalangeal joint (Figure 1). The surrounding area appeared to be normal with no signs of any infection. Glove type toe prosthesis was planned for the replacement of the missing hallux. After having informed consent from the patient, to ensure his willingness and cooperation the treatment was executed [3].

Figure1: Preoperative photograph showing missing hallux of right foot.

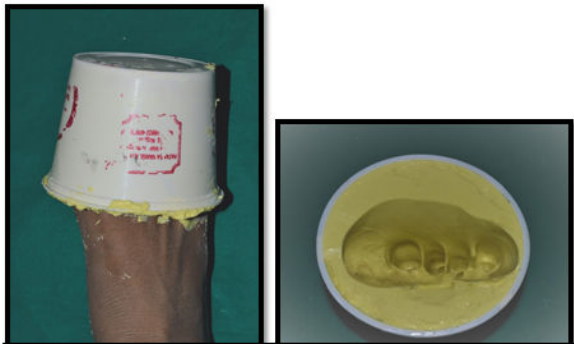
A thin layer of irreversible hydrocolloid impression material was placed over the plantar side first and then the dorsum aspect of foot. The patient was instructed to keep the foot in the normal resting position without stretching while impression making (Figure 2a and b). Also impression of the left foot was made following the same procedure.

Figure 2(a and b): Impression making of the affected foot.

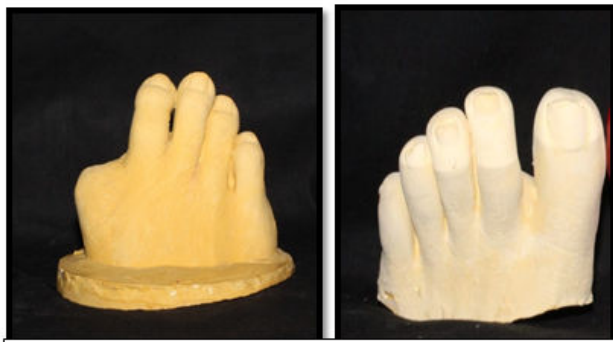
When the material was set the impression was retrieved and fabrication of model was carried out. Both the impressions were poured in stone plaster, type-III (Figure 3a and b). At the same appointment another impression was made of patient's left foot hallux in a combination of light body and putty (Figure 4). The impression of the patient's left foot hallux was poured with wax. The pattern was retrieved from the elastomeric impression [4].

Figure 3(a and b): Stone model obtained of right (a) and left foot (b)

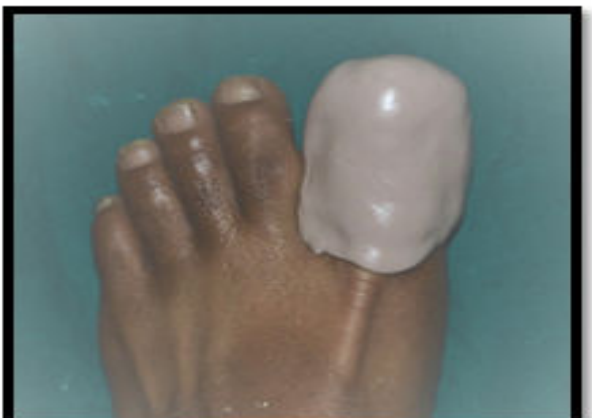
Figure 4: Putty and light body impression made of hallux of left foot.

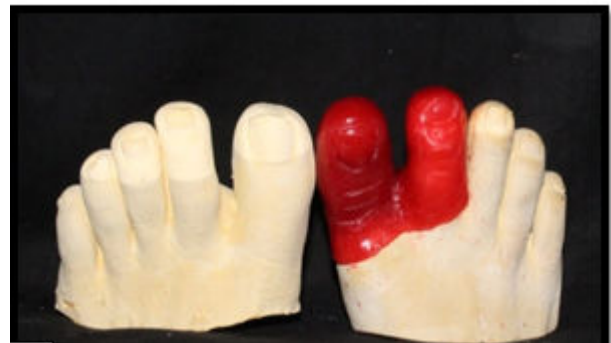
The wax pattern was then adjusted by sculpting and adapted on the working cast. Approximate length and

angulations were determined on working cast and later confirmed during trial of wax pattern (Figure 5). The wax pattern was tried on the patients affected foot (Figure 6).

Figure 5: Wax-pattern for prosthesis.

Wax was preferred over clay to make the pattern because residual oils from clay contaminate the mold surface, which interferes with the platinum catalyst employed in silicone prosthesis materials. The resultant wax was pliable enough to form into small shapes with fingers when warm, yet stiff enough to carve with an instrument when chilled. Placing it in chilled water for some time prevents distortion of the pattern. If any surface details were lost, then the wet gauze technique was used to recreate surface details. Silicone prostheses do not have color longevity. The ideal color properties required in a maxillofacial prosthetic material must accept and retain intrinsic and extrinsic coloration [8].

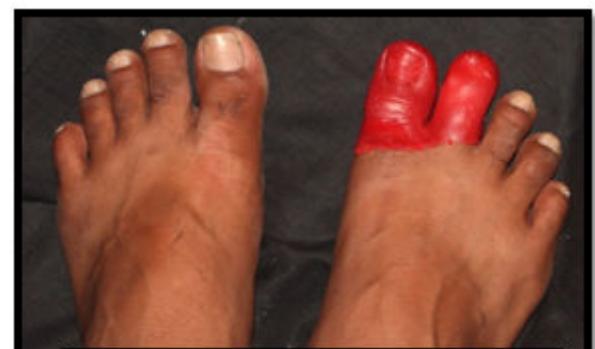
Figure 6: Try-in of wax pattern.

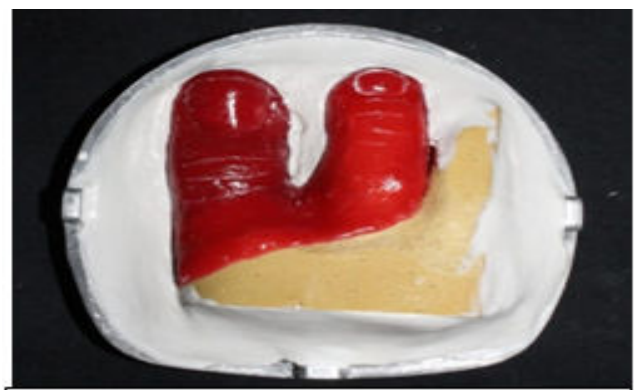
The master cast was duplicated and the duplicate cast was used for investing. The pattern was sealed to the master cast at the junction, where the margins of the pattern overlapped the cast. The pattern and the cast were then invested in a large size flask [5]. The mold was first poured only up to half of the pattern (Figure 7). Separating medium was applied and then the other half was poured, wax was eliminated in the conventional way (Figure 8).

Figure 7: Flasking of the wax pattern.

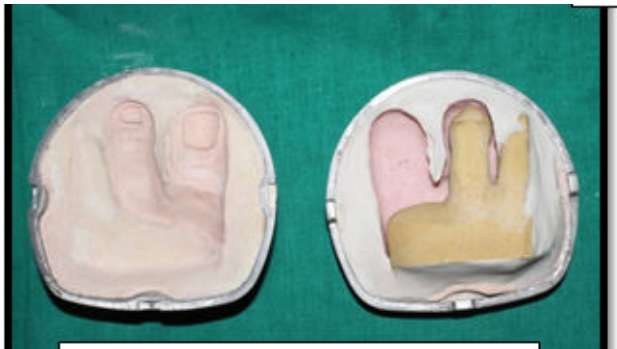
Figure 8: Dewaxing

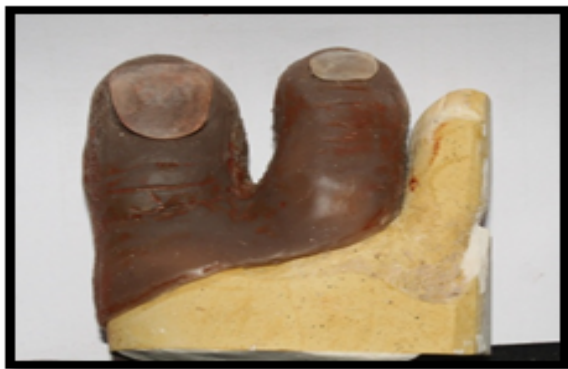
Figure 10: Final prosthesis

The final prosthesis was obtained and was trimmed and finished (Figure 10). Nail was fabricated using cold cure clear acrylic and attached to the prosthesis using cyanoacrylate. The prosthesis was tried in the patient. Extrinsic staining and dematting was done to match the exact color (Figure 11). The prosthesis was finally delivered to the patient after giving instructions regarding its maintenance.

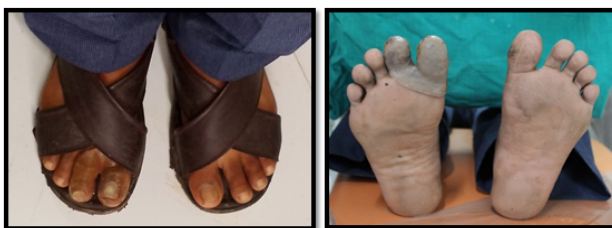
Figure 11: Final prosthesis after extrinsic staining
